# North Shoreline Restoration

# Monitoring: Phase 1 – South Shoreline

# Phase 2: North Shoreline Monitoring

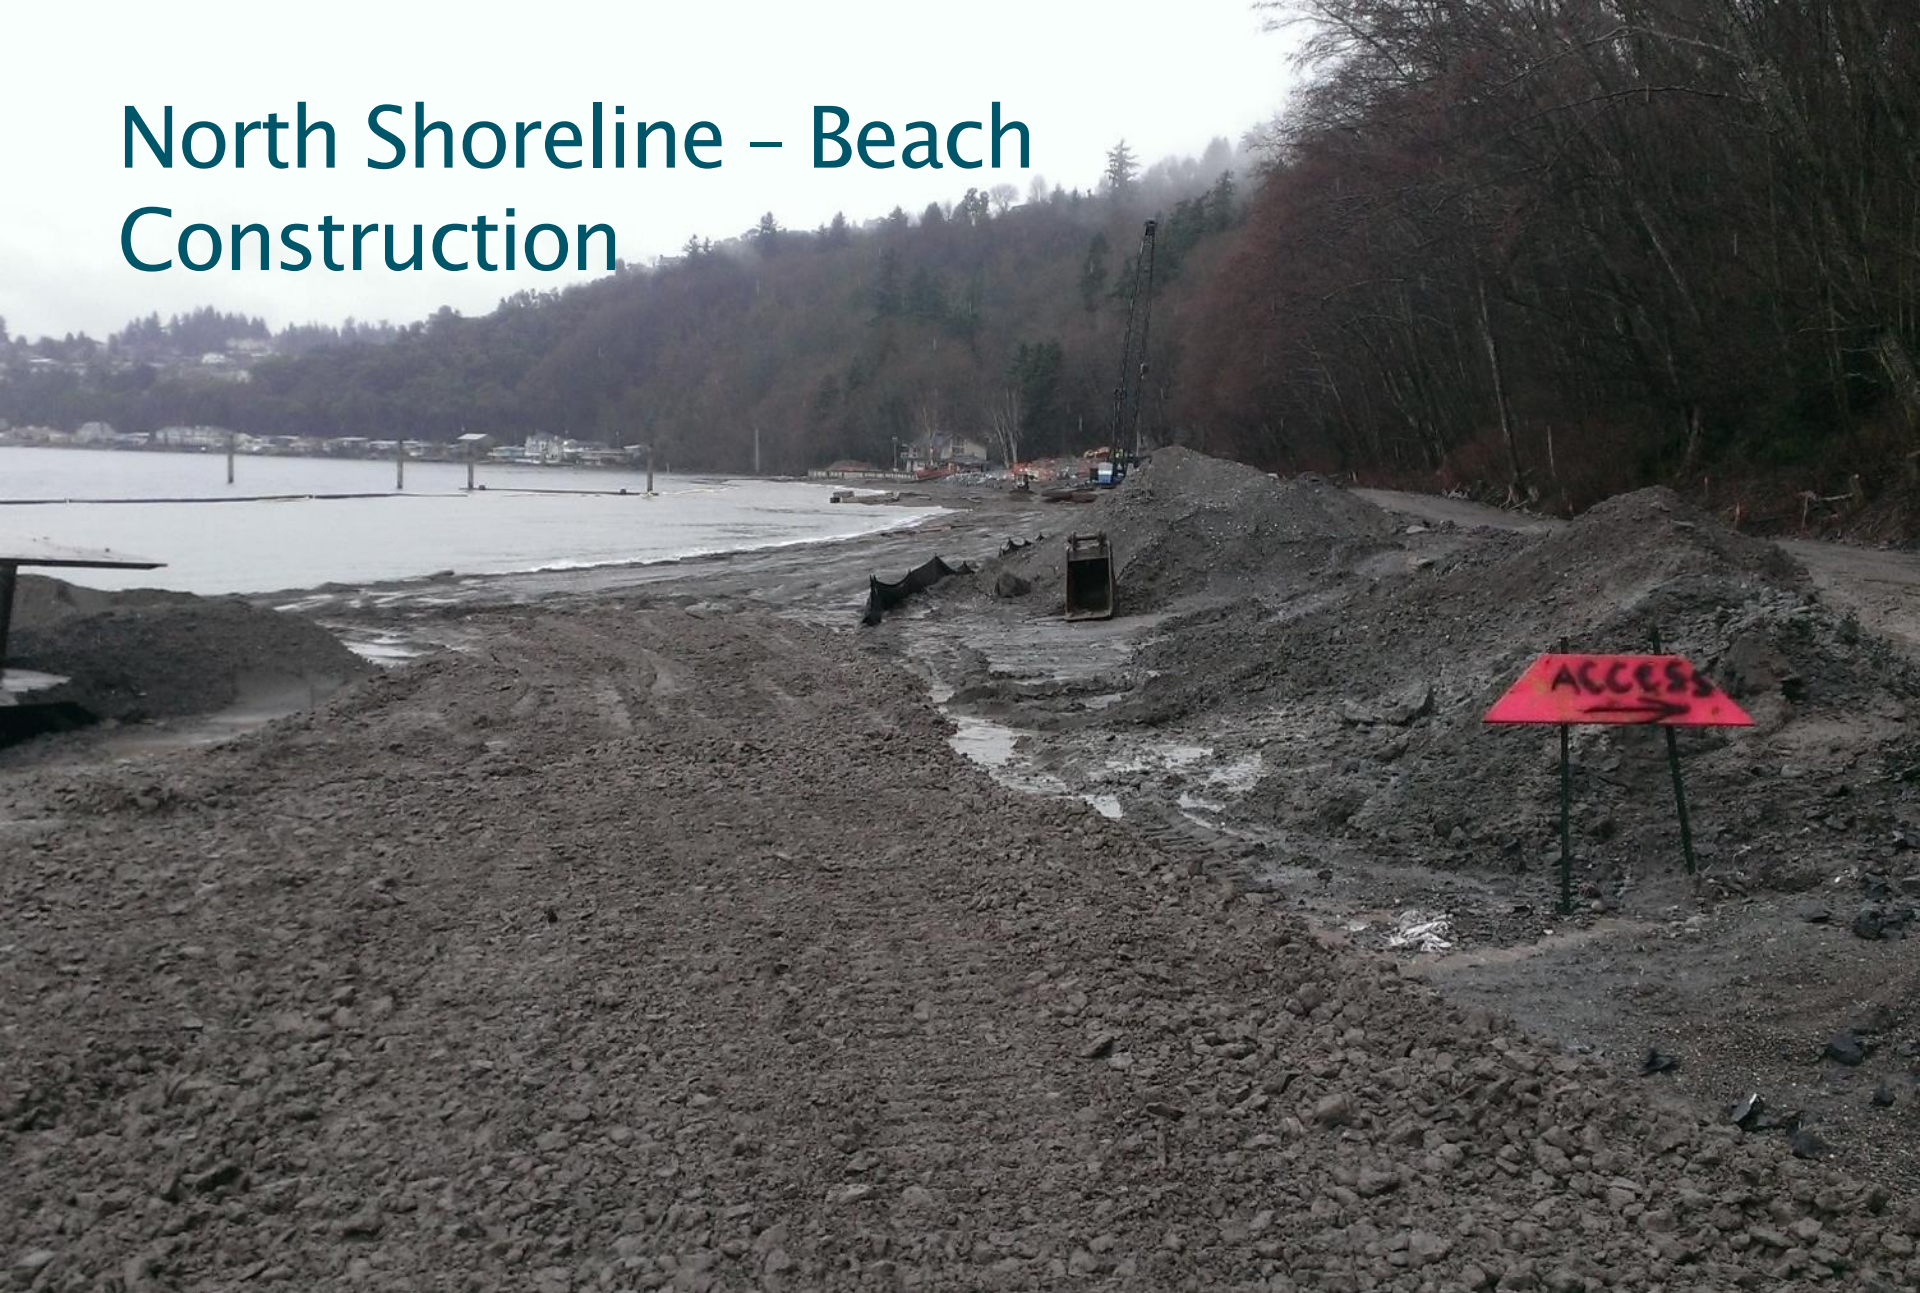
# North Shoreline – Beach Construction

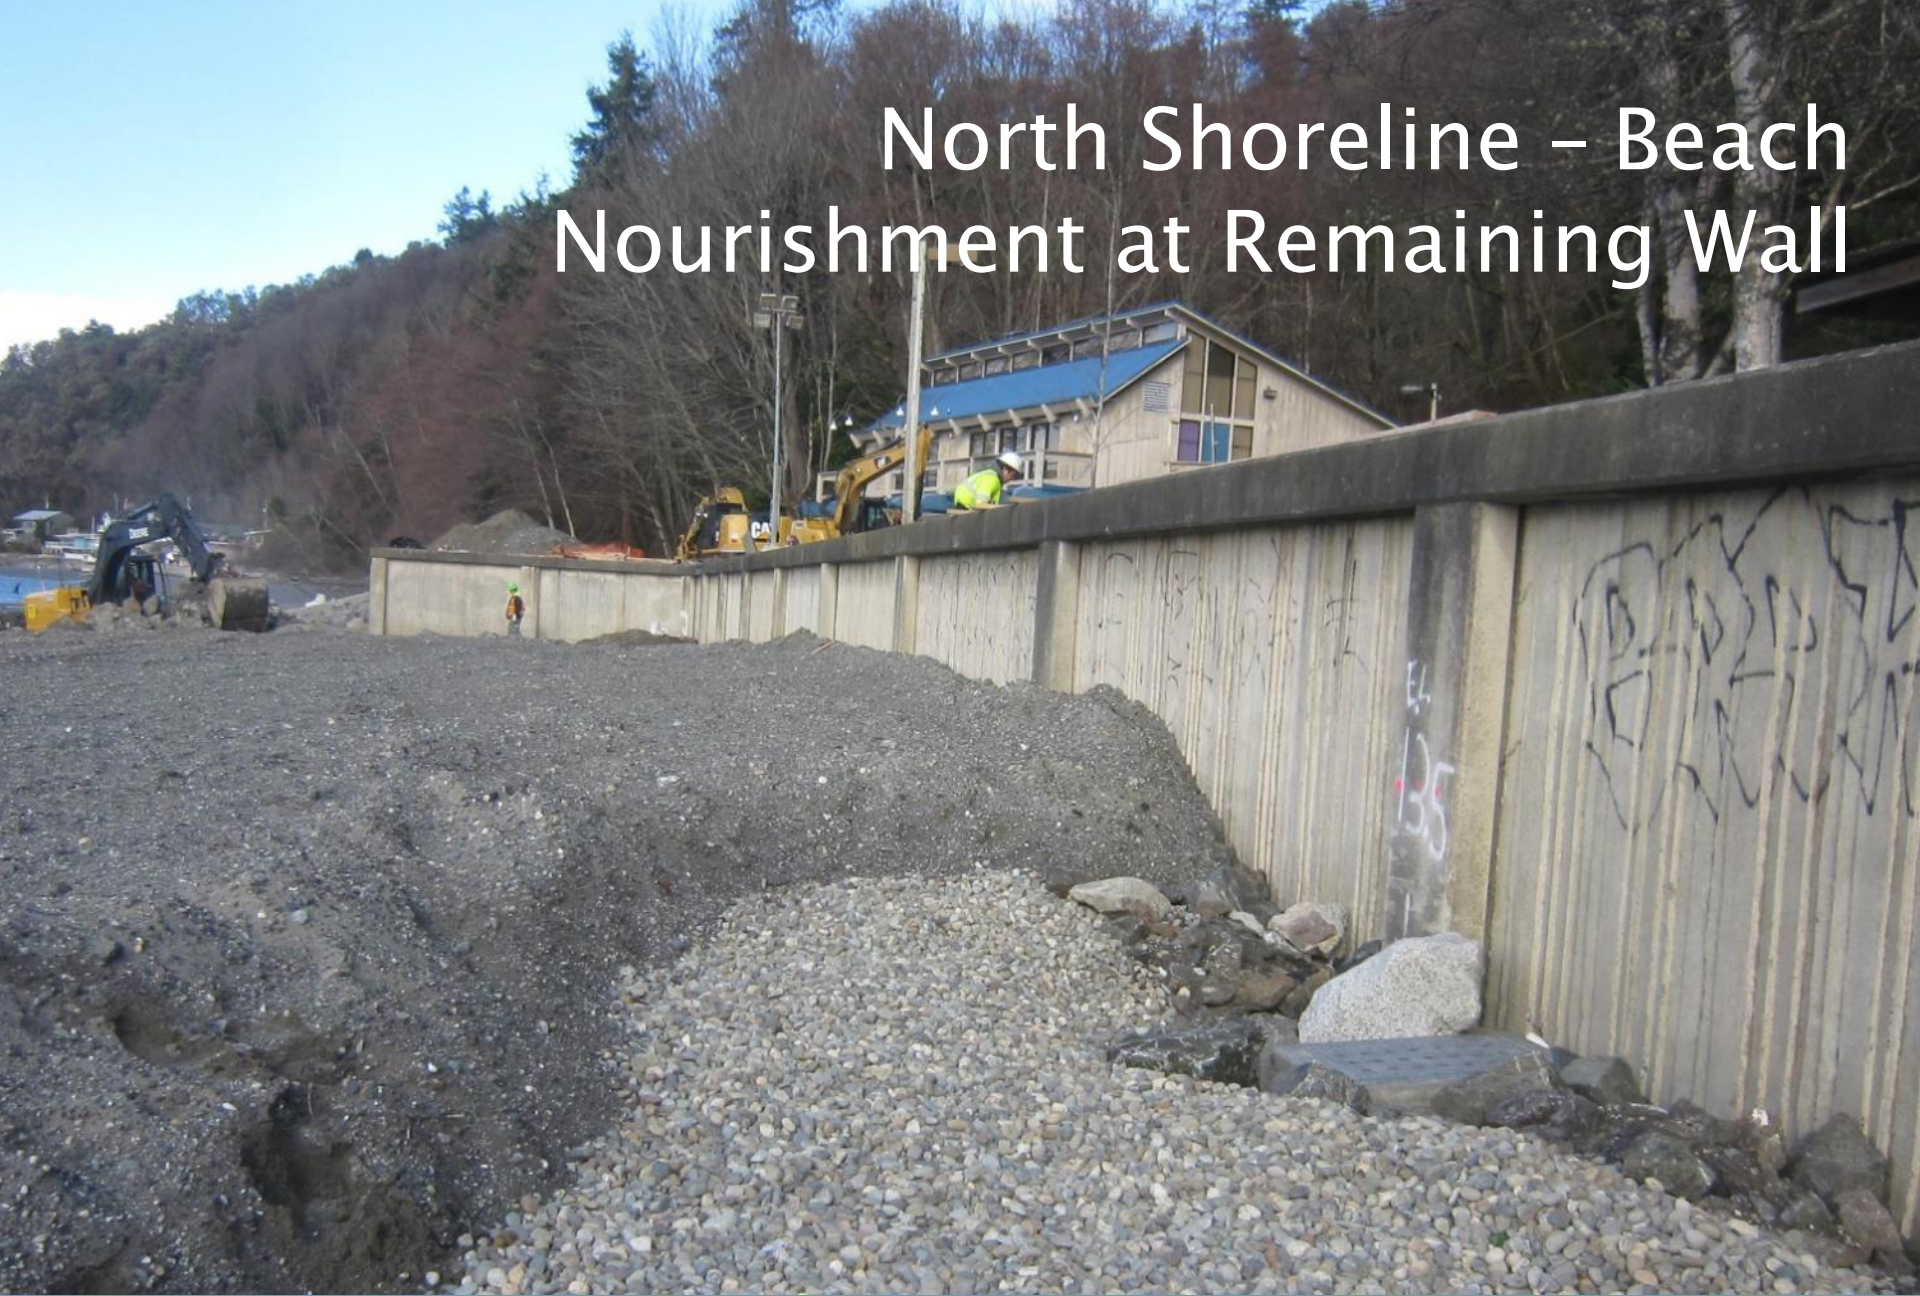
# North Shoreline – Beach Nourishment at Remaining Wall

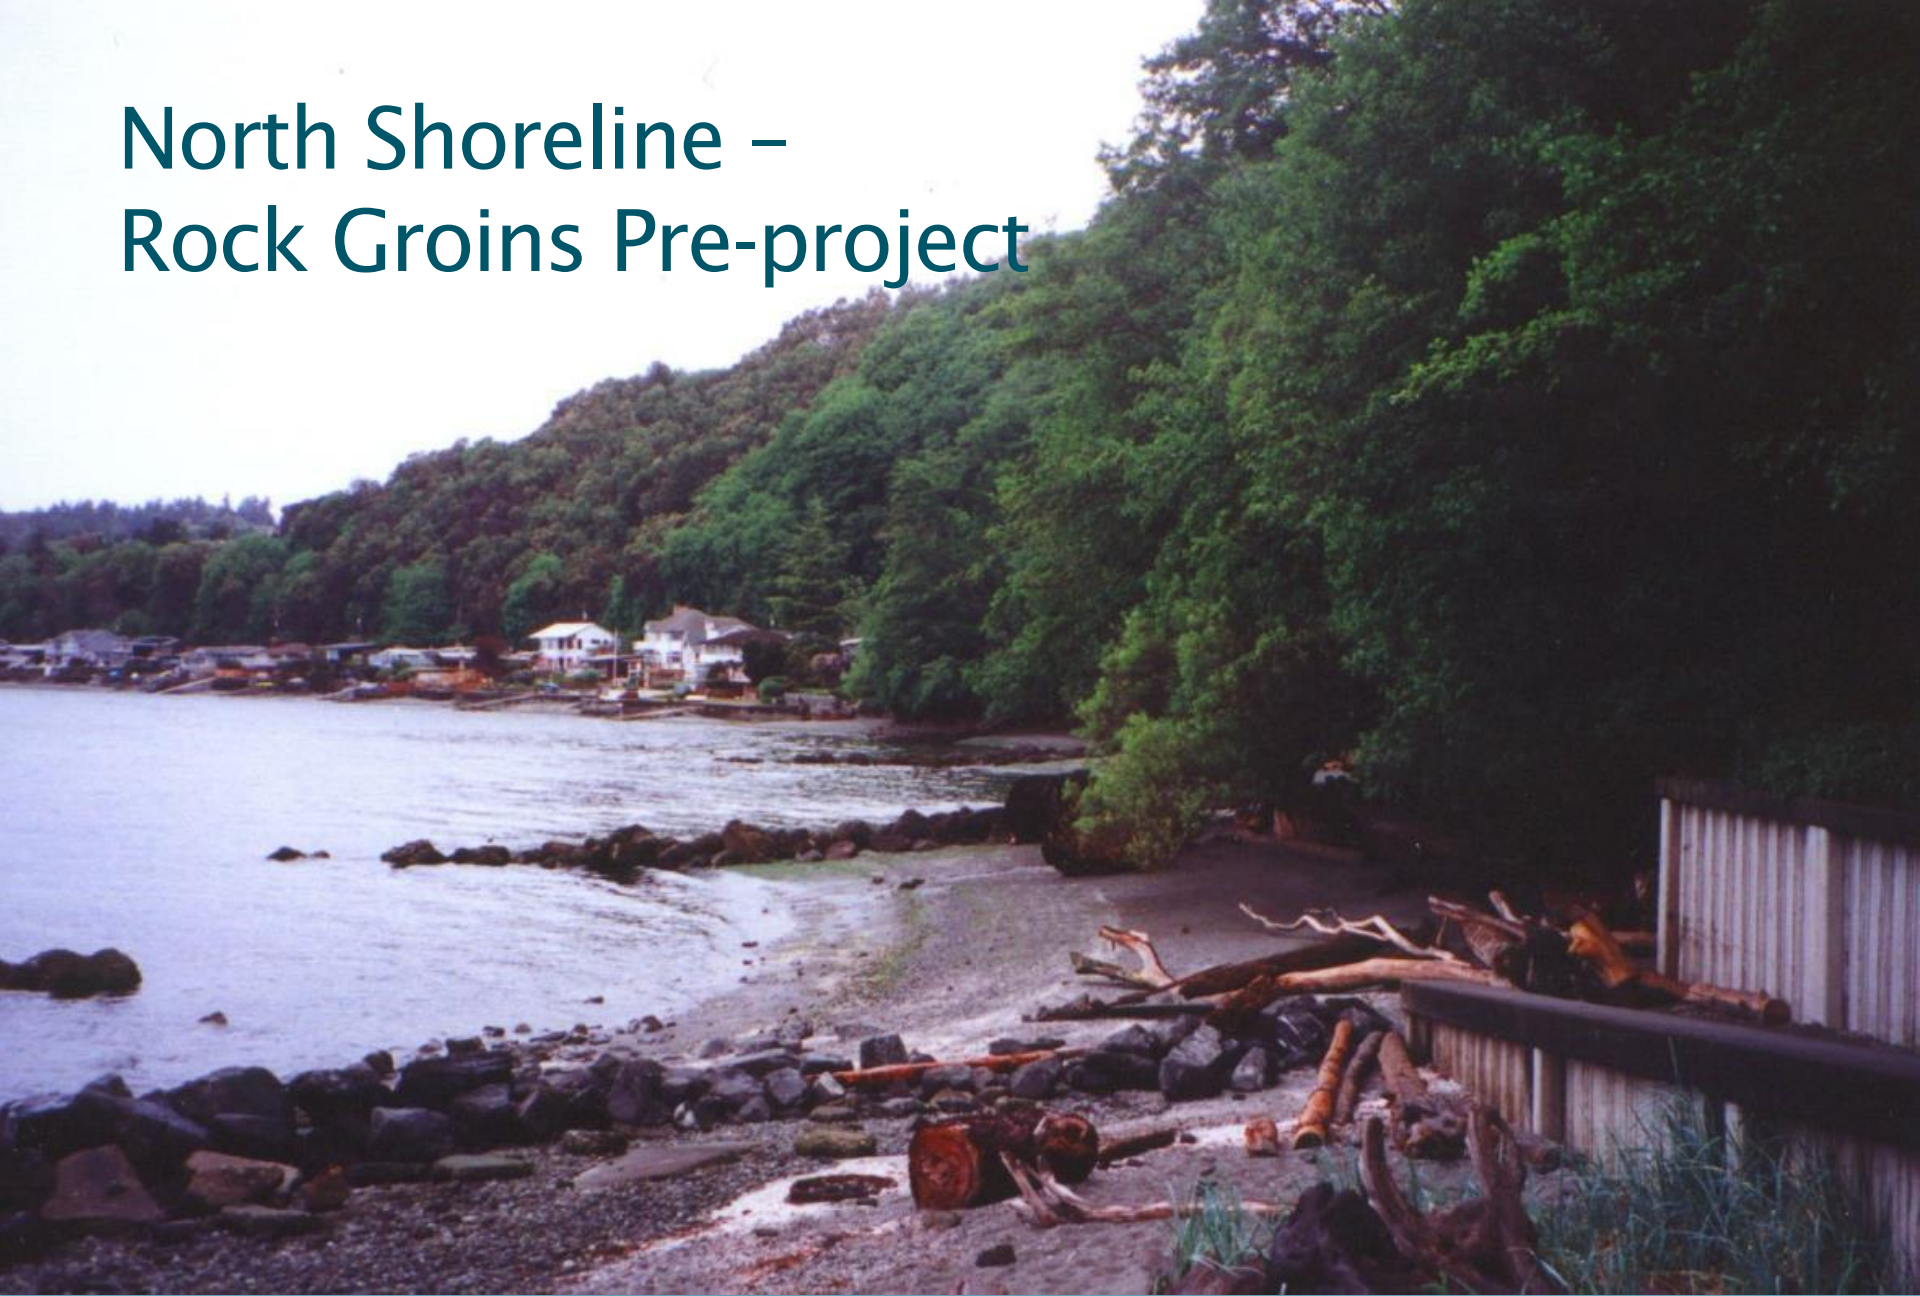
# North Shoreline – Rock Groins Pre-project

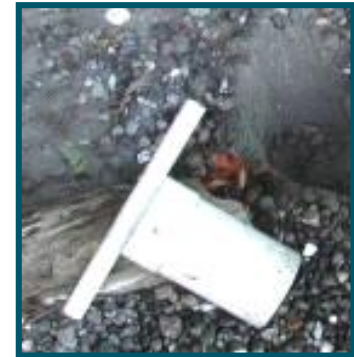
**Benthic Invertebrates:** Three different tidal elevations

1. +12: Wrack line
2. +8: Base of modifications
3. +5: Low elevation of beach regrade

**Physical Monitoring (by CGS):**

Substrate size, beach profiles, and overall sediment movement

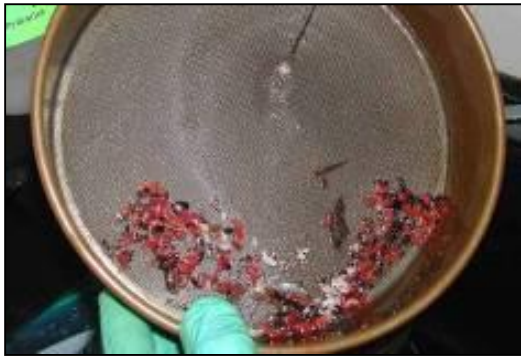
# Phase 1: Benthic Macro-invertebrates at Different Tidal Elevations

**Densities:** Improvement at Restored site in 2010 where modifications were removed (+12 and +8), but densities still greater at Reference site, at +12 and +5.

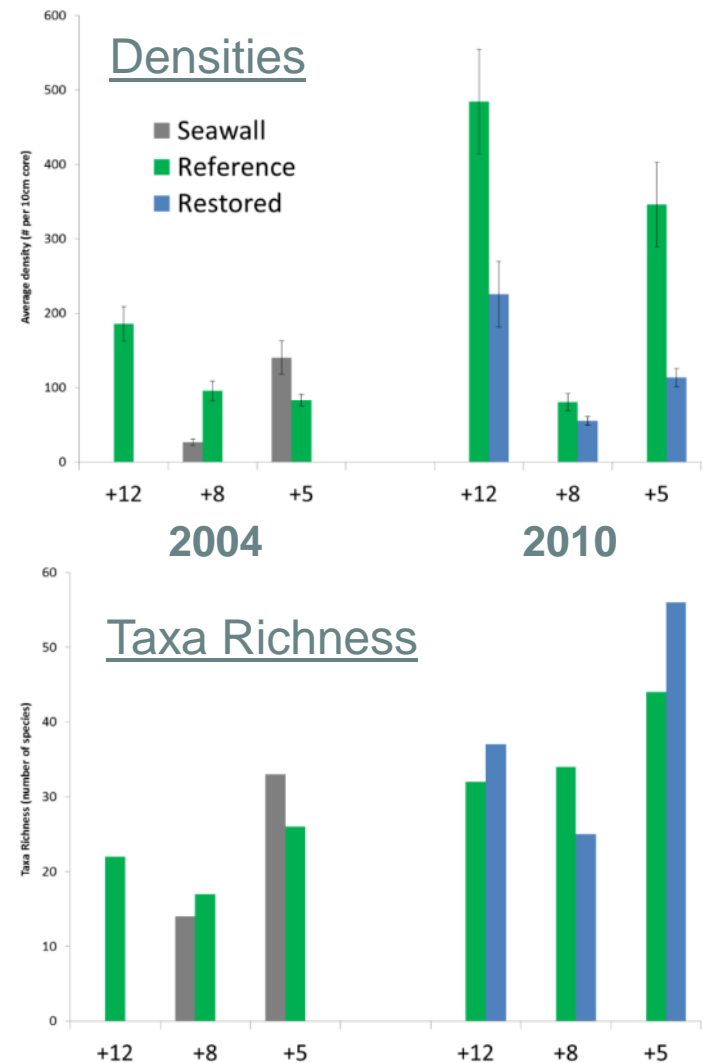
**Taxa Richness:** Improvement at Restored site in 2010 at all elevations, greater than Reference at +12 and +5, less at +8.

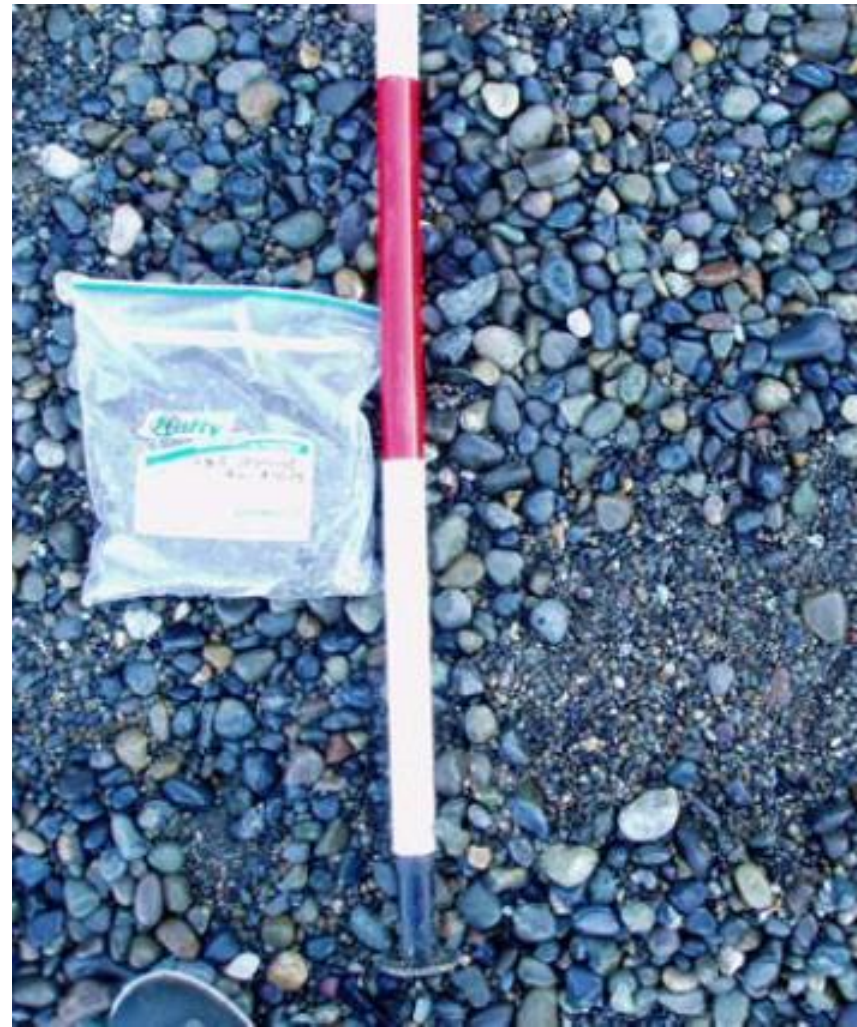
# Phase 1: Physical Beach Sediment Monitoring

- Monitoring began prior to beach restoration and occurs at two seasons a year (since 2004)
- Overall beach is relatively stable, with localized increases and decreases in sediment
- Most significant loss of material is lowering of upper beach backshore at south end of project
- Significant proportion of beach is now suitable sediment size for forage fish (sand lance and surf smelt) spawning – a primary goal of the beach restoration
